PRELIMINARY SOIL AND GROUNDWATER ASSESSMENT OF CANTON DROP FORGE, INC. 4575 SOUTHWAY STREET, SW CANTON, OHIO

February, 1993

Prepared by:
Lawrence D. Phillips, P.E.
Hammontree & Associates, Limited
5233 Stoneham Road
North Canton, Ohio 44720

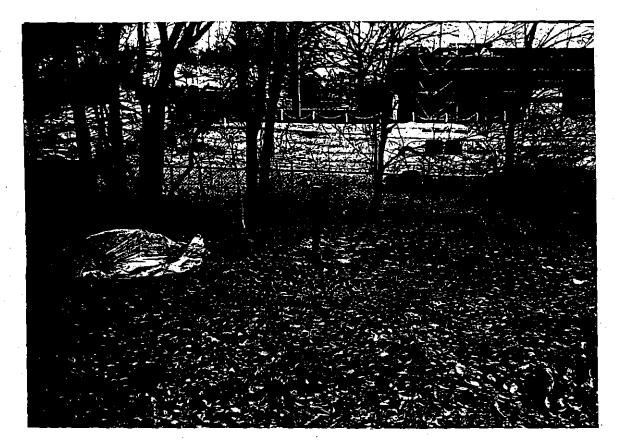
MW-2 LOOKING WEST

For other metal concentrations in the groundwater and soil samples refer to the R & R Report Tables 5.5 (pages 31 thru 33) and 5.10 (pages 41 thru 43). The metal concentrations in the soil are within normal background levels according to the US Geological Survey Professional Paper 1270 dated 1984 except for arsenic (170 mg/kg in B-7), Chormium (2000 mg/kg in B-6), and nickel (1800 mg/kg in B-6). The lead in MW-2 was retested and showed below the detection limit.

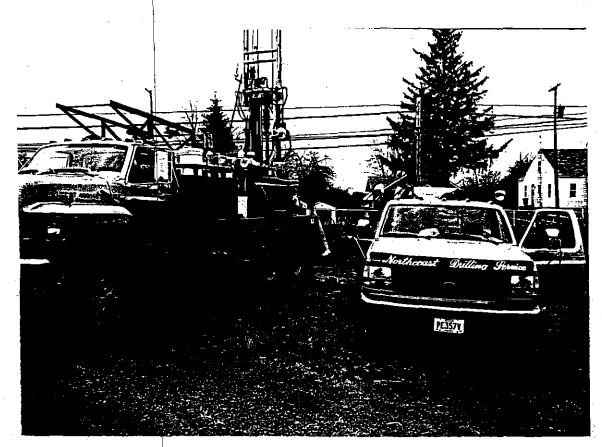
B-5 LOOKING SOUTH

- Eight (8) monitoring wells were advanced on the site to depths up to 50 feet and found to contain insignificant soil or water contamination. Soil samples for B-5, B-6, and B-8 showed high hydrocarbons ranging from 4400 mg/kg to 6800 mg/kg. No groundwater remediation is indicated, because the total petroleum hydrocarbons are low and no related regulated constituents were found such as BETX.

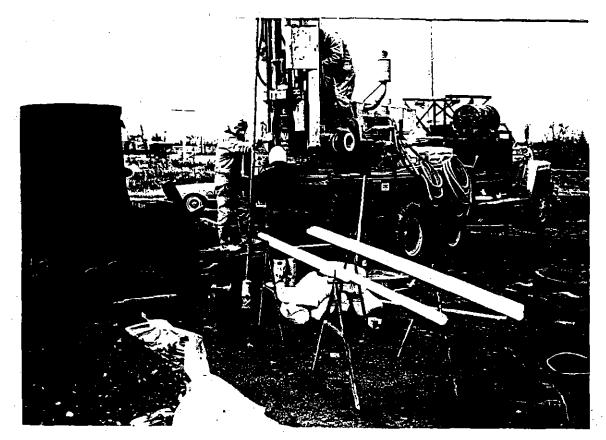
B-6 LOOKING EAST

- Very limited quantities of Polychlorinated Biphenyls (PCB's) were found in the soil at Test Hole B-6 @ 0.31 mg/kg. PCB #1260 was also found on the surface near one of the transformer locations, HB-1, at 0.88 mg/kg. The maximum concentration limit goals (MCLG) = zero (40 CFR 141.50).

HB-1 indicated a concentration of 0.88 mg/kg of Aroclor #1260 PCBs. Also PCB's were identified at B-6 having a concentration of 0.31 mg/kg. The contamination was at about 1 foot and 5 foot,
